## FRACTURE IN CARBON-EPOXY COMPOSITES

BY J. R. LOWNEY  
J. F. GOFF

30 SEPTEMBER 1977

4. TITLE (and Subtitle)	5. TYPE OF REPORT & PERIOD COVERED	
6 Fracture in Carbon-Epoxy Composites.	First Annual Report (1 Oct '76 - 30 Sept '77)	
	6. PERFORMING ORG. REPORT NUMBER

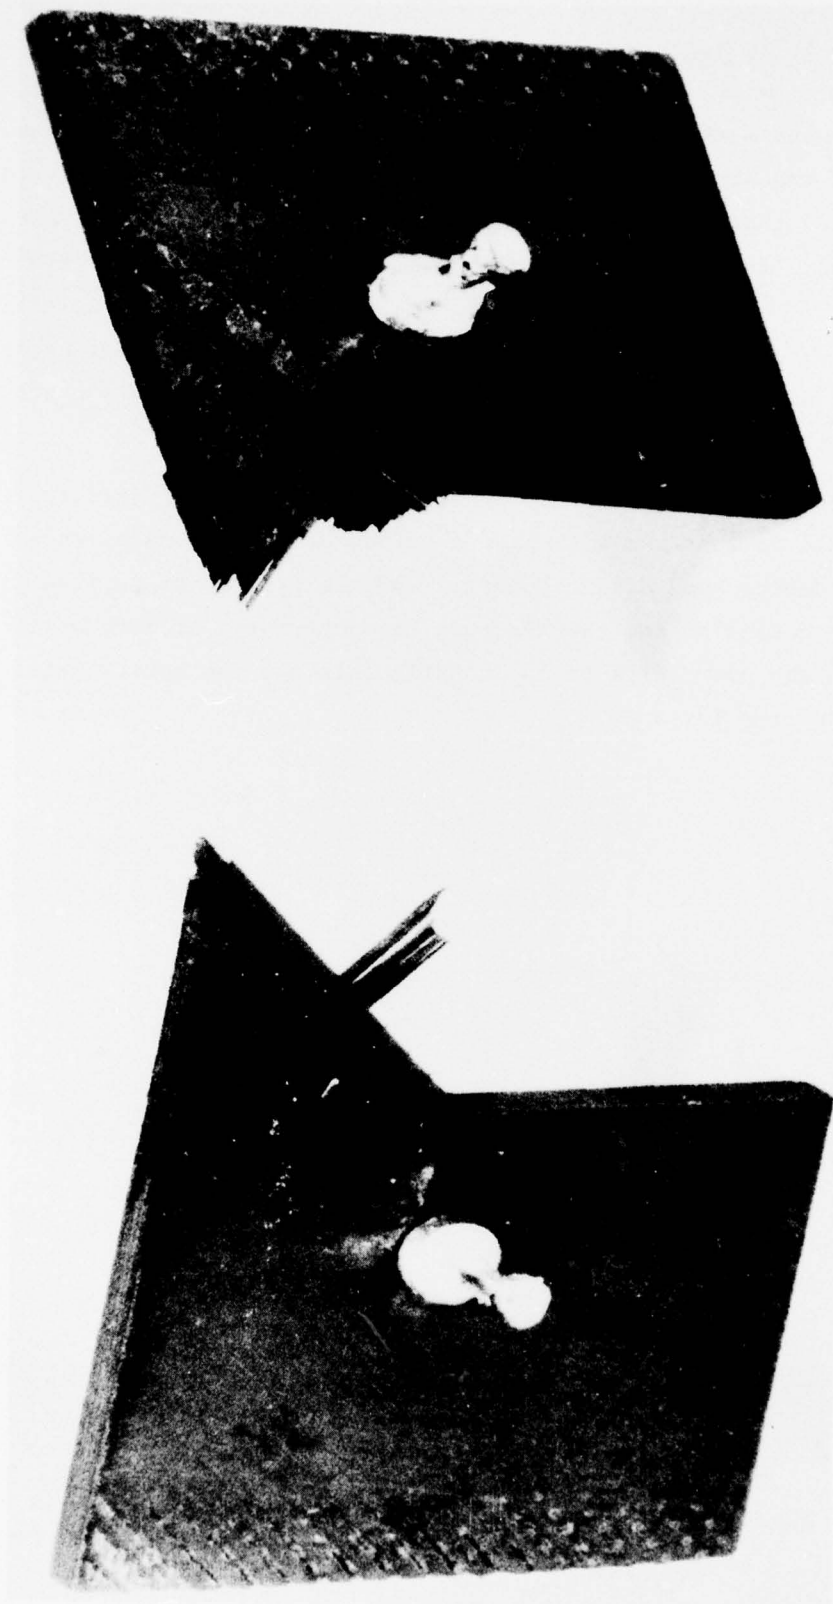
FIGURE 1 FRACTURED SAMPLE WITH CROSS-PLY OF  $\pm 45^\circ$

In order to distinguish between the cracking of the matrix and the breaking of a fiber, we monitored the electrical resistance while fracturing sample NRL(577). Leads were attached as shown in Fig. 1 to be close to the fracture without interference. In retrospect these contacts could have been farther away.

Examination of Fig. 1 shows how the sample failed. Two cracks emanated from the crack tip; one was parallel to each set of fibers. The sample then delaminated and separated without ever breaking any fibers.

Another sample NRL(607) with a  $\pm 37\frac{1}{2}^\circ$  cross-ply angle showed a dual crack fracture like that in Fig. 1 and a complex stress/electrical pattern like that in Fig. 10. This sample had an initial resistance of 0.090 ohms and a critical fracture tension of 120 Kg. A final point is that the critical angle for which the failure mode changes from simple matrix fracture with subsequent fiber disbonding and shear to matrix fracture and delamination without any fiber fracture must lie between  $11^\circ$  and  $37\frac{1}{2}^\circ$ .

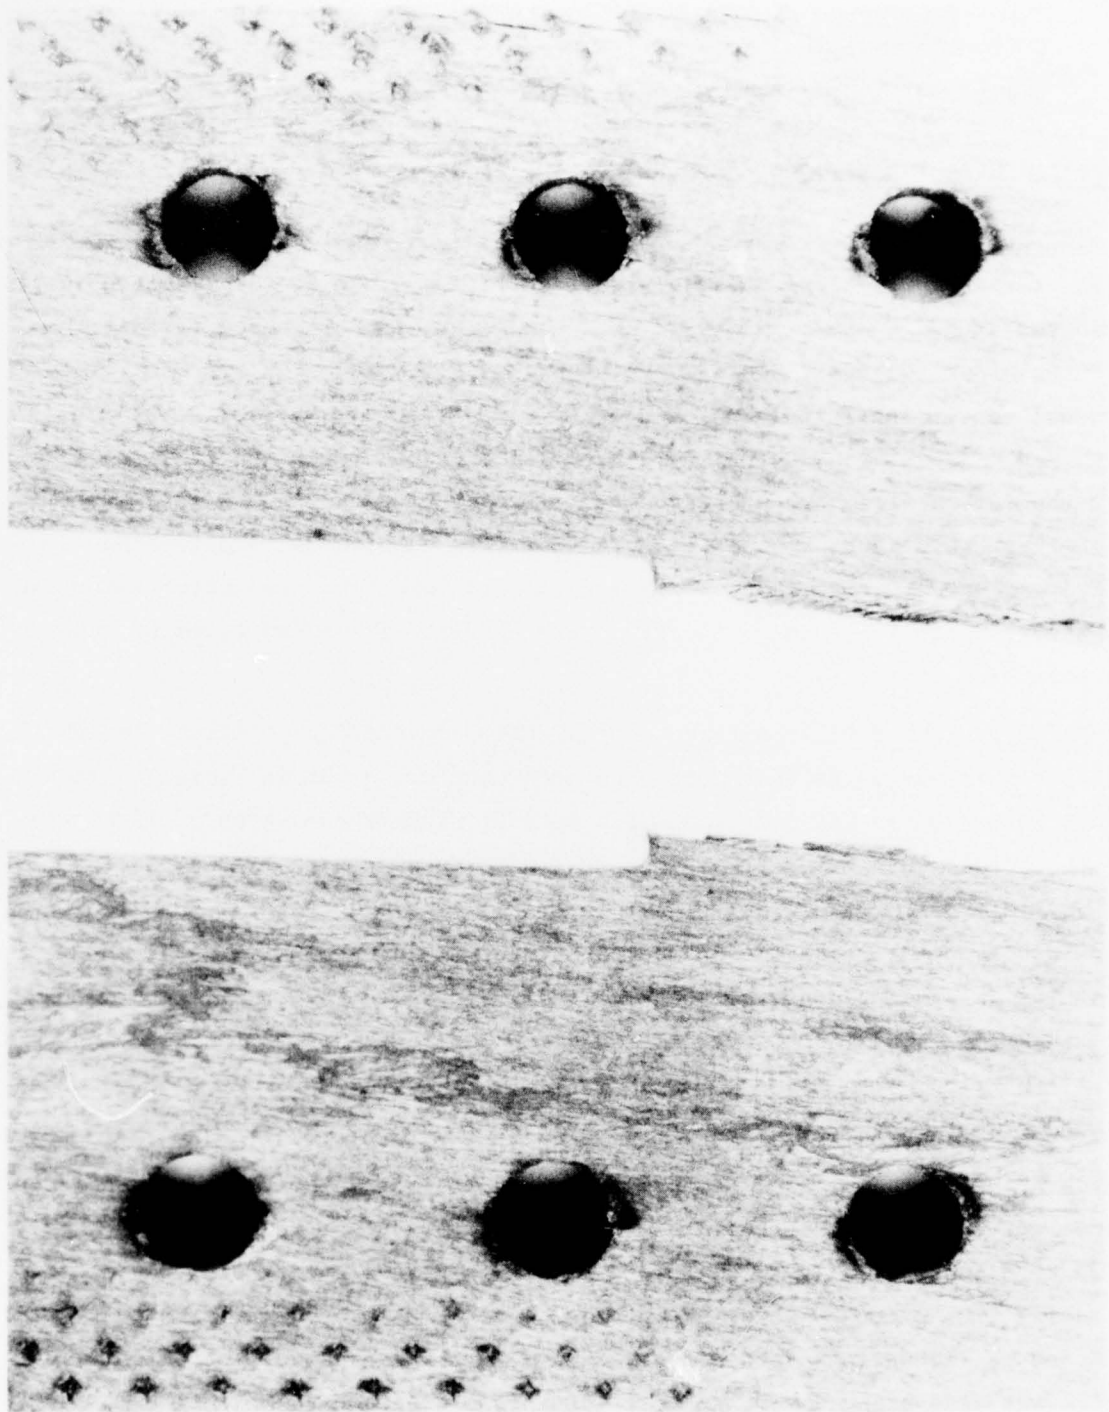
FIGURE 2 FRACTURED SAMPLE WITH CROSS-PLY OF  $\pm 6^\circ$ .

The first sample which was measured was unlabeled. It had a lay-up of  $(\pm 6\frac{1}{2}^\circ)_{8s}$  and dimensions of  $13/16'' \times 25/32''$  with a  $1/32''$  wide notch  $15/32''$  long cut in the center of a  $13/16''$  edge. The sample was  $0.10''$  thick. The result of straining this sample to fracture is shown in Fig. 2. The three holes that can be seen in the sample were placed there by NRL and did not affect our results.

The complete failure of this sample occurred in a sequence. When the supported tension reached 36.5Kg, a crack appeared which ran from the notch tip to the sample edge. A check of the sample for electrical continuity after it had been removed from the Testing Instrument showed that a large number of the fibers were still intact; in fact the sample still held together. However, under subsequent strain the sample would support only 2.3 Kg and gradually completely pulled apart. Subsequent metallurgical micrograph studies showed that the crack ran from the notch-tip parallel to one of the sets of fibers. After this initial crack, the other set of fibers pulled and then sheared.

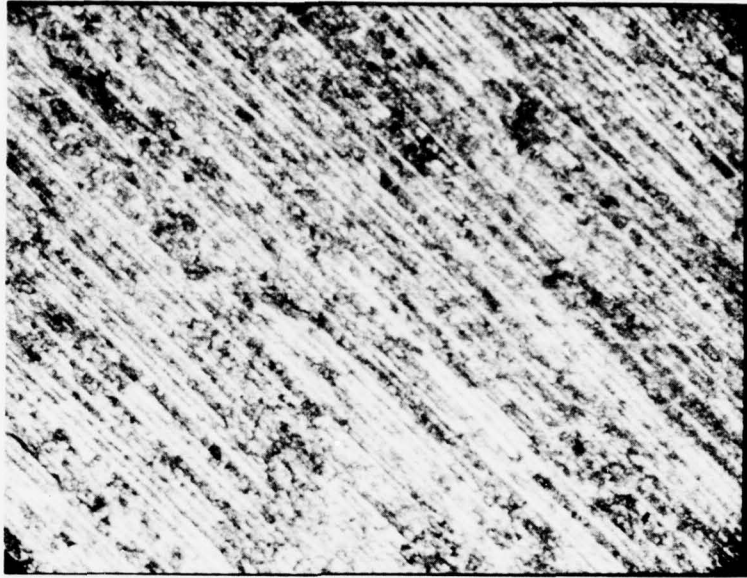
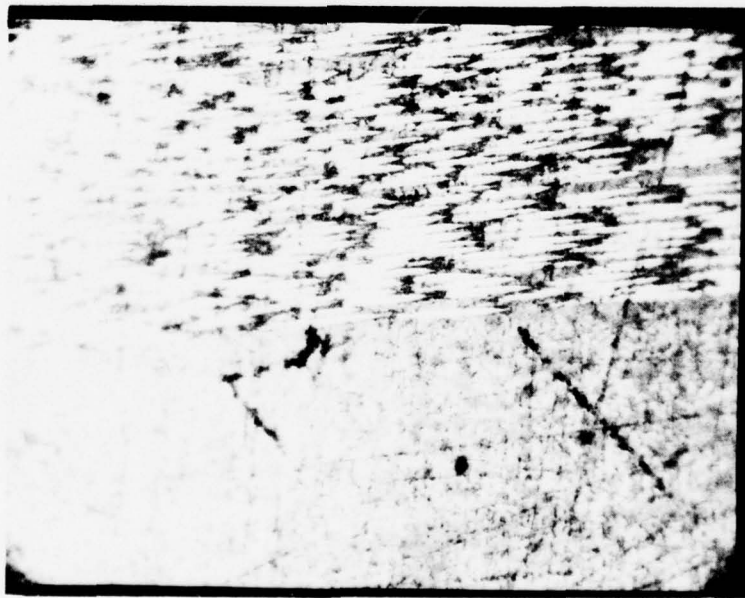
FIGURE 3

(a) SAMPLE FROM NRL SHOWING FIBERS IN PLANE (X200)

(b) SAMPLE FROM NSRDC-CARDEROCK SHOWING FIBERS IN PLANE (TOP)  
AND ON EDGE (BOTTOM) (X200)

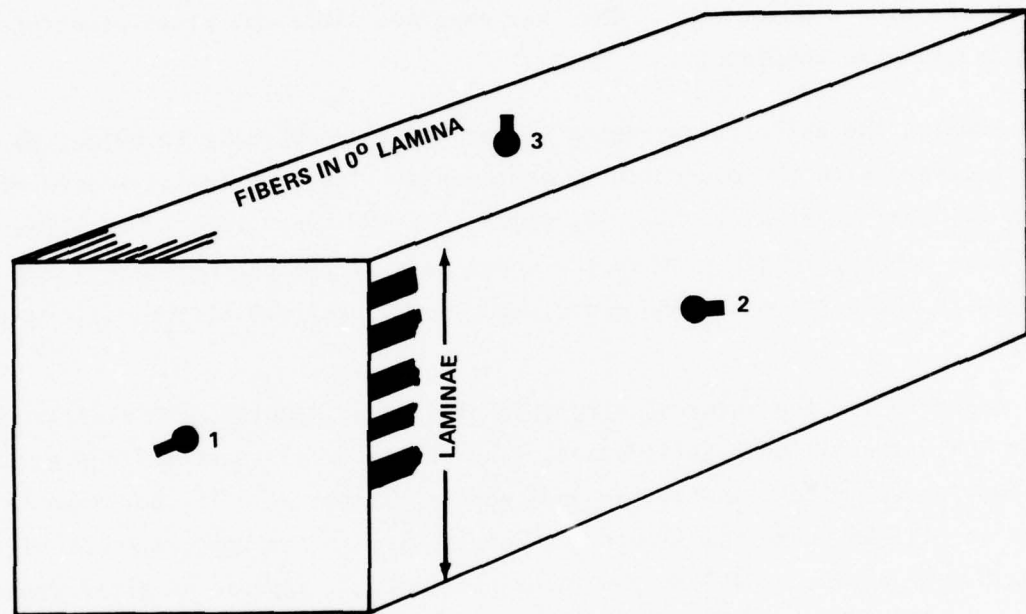
FIGURE 4 BOX BEAM SAMPLE (NSRDC) WITH ELECTRICAL PLUGS

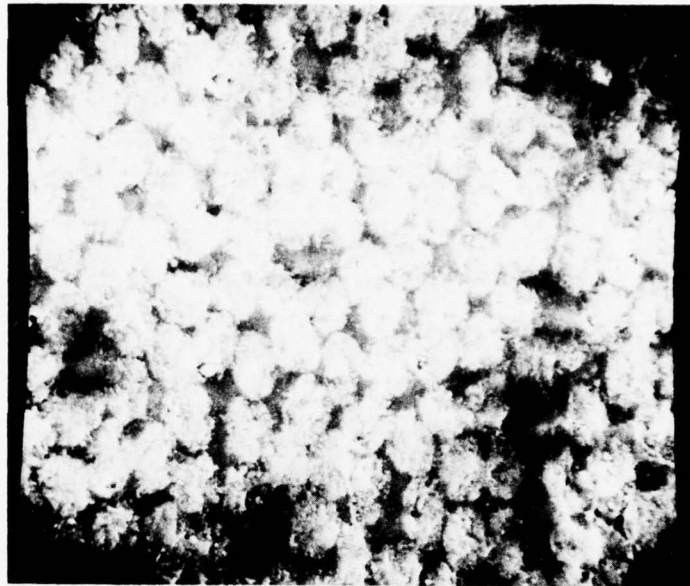
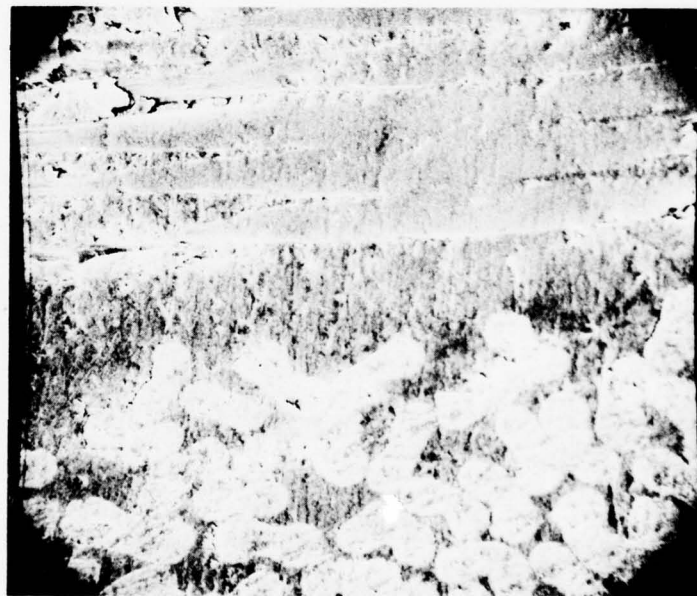
FIGURE 5

(a) NRL SAMPLE SHOWING FIBERS ON EDGE (X10000)

(b) NSRDC SAMPLE SHOWING FIBERS LENGTHWISE (TOP)  
AND ON EDGE (BOTTOM) (X10000)

These photographs also show the difference between the fibers used to construct the two samples. The Thornel 300 fibers have a distorted, circular cross-section while the GY 70 ones have a dog-bone shape. The different shapes and types of fiber and the different amounts of fiber touching must affect the strength of the material.

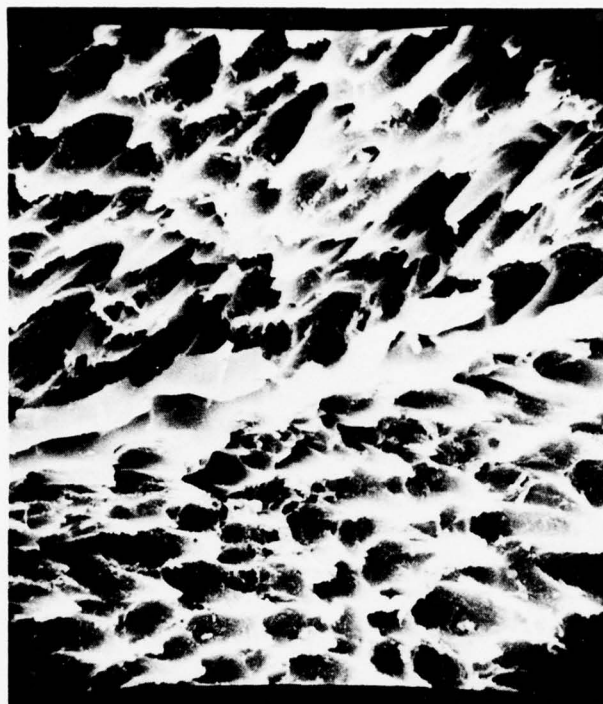
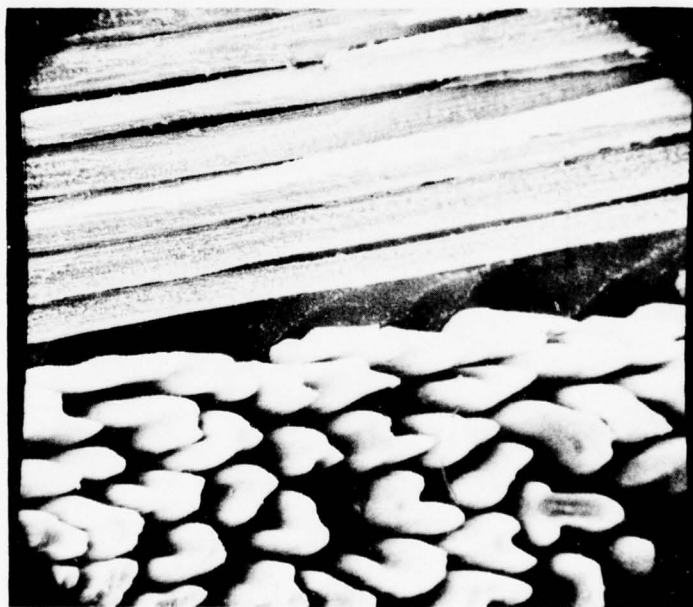
FIGURE 6

(a) NRL SAMPLE SHOWING INTERLAMINA REGION AFTER ETCHING (X1000).

(b) NSRDC SAMPLE SHOWING INTERLAMINA REGION AFTER ETCHING (X1000).

A curious result is the difference of the effect of the same etch on the two materials. In the case of the NRL material the carbon fibers were etched away leaving ridges of matrix material interconnected as can be seen in Fig. 6a. On the other hand, the Box Beam material shown in Fig. 6b shows the matrix etched away with

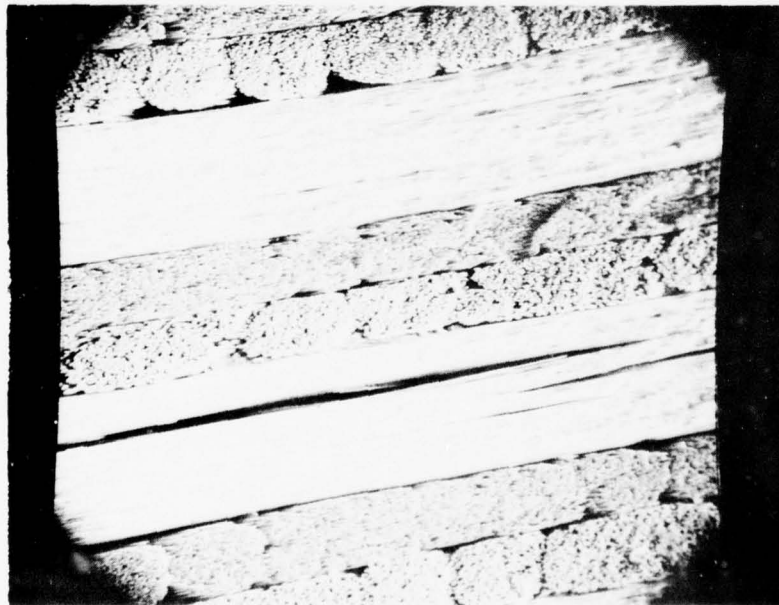
FIGURE 7

(a) NRL SAMPLE SHOWING FIBERS ON EDGE AFTER ETCHING (X50)

(b) NSRDC SAMPLE SHOWING FIBER LENGTHWISE AND ON EDGE AFTER ETCHING (X50).

Finally, it should be noted that a delamination that is visible in the lower, longitudinal lamina in Fig. 7b would constitute a weak area in the composite and would initiate fracture at subcritical loads.

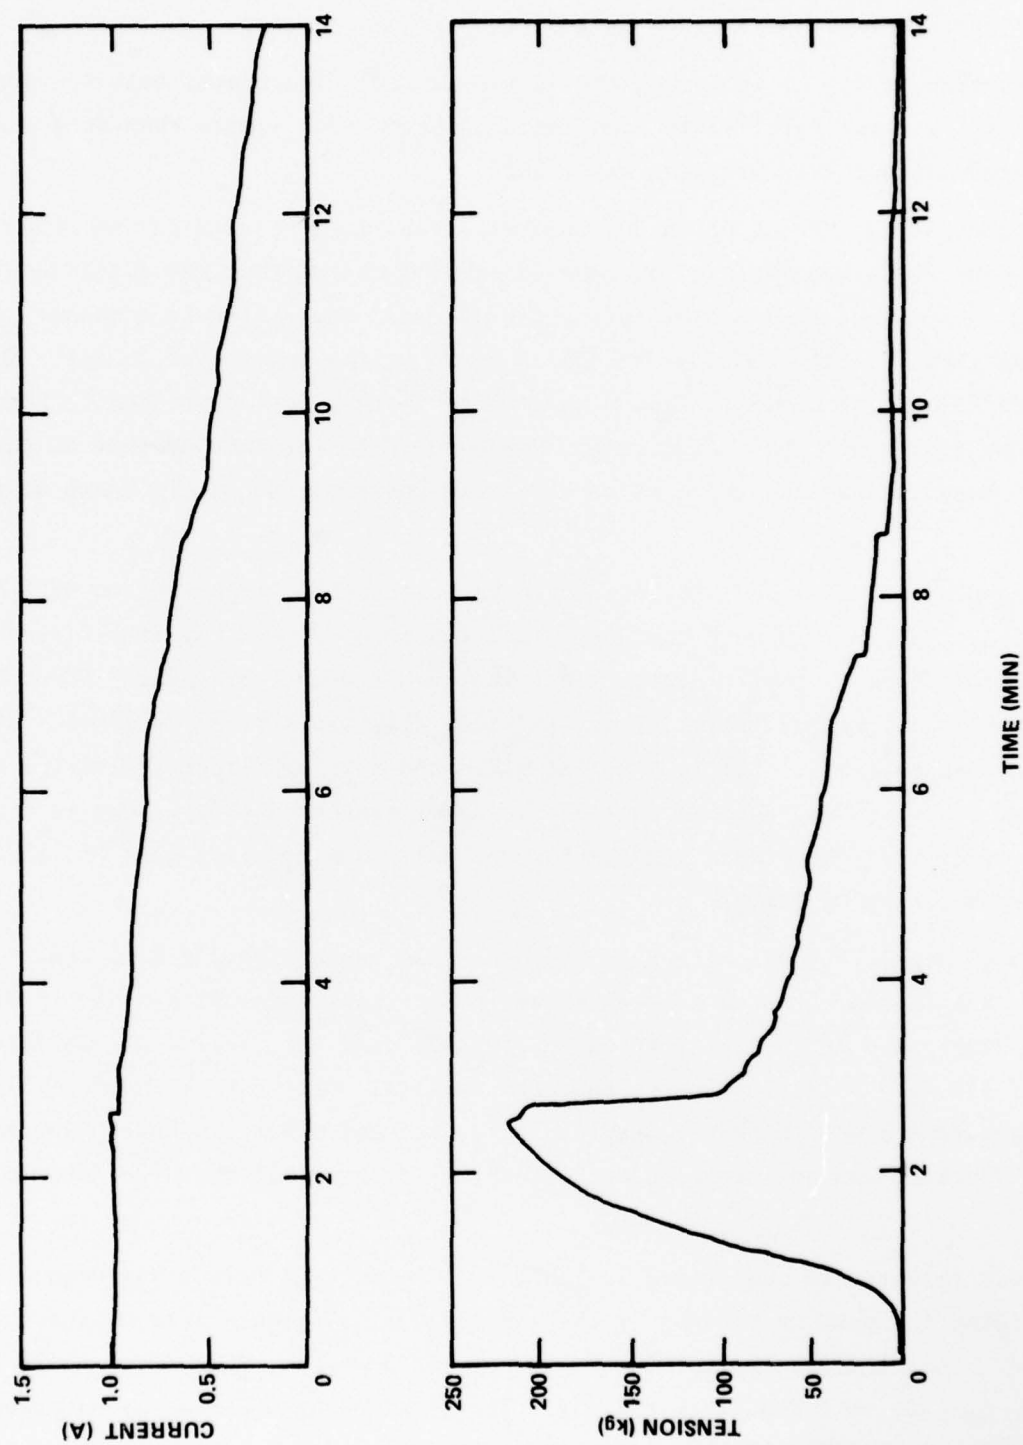
FIGURE 8 VARIATION IN SAMPLE CURRENT AND APPLIED STRESS DURING FRACTURE (NRL 577)

A current from a DC power supply was passed through the sample. Its value was obtained by measuring the voltage drop across a 0.1 ohm standard resistor, and its trace recorded. The behavior of this trace is shown in Fig. 8. Some changes in the sample that occur prior to fracture produce small changes in the sample current. These changes which seem to indicate a decrease in the sample resistance may indicate that individual filaments are being compacted more tightly in the fibers. Thus the fiber resistivity may decrease although the filament resistivity would be expected to increase. The initial sample resistance was 0.19 ohms.

The trace of the tension that arose from the constant strain rate is shown in Fig. 8 as well. Fracture is clearly indicated by the sudden drop of this tension from 216 Kg. The non-linearity prior to fracture is not understood at this time. At fracture the supported tension dropped within about  $\frac{1}{2}$  sec from 216 Kg to 100 Kg. Thereafter, it gradually decreased as the sample disintegrated and separated. On the contrary the initial drop in the sample current was only 2%. The corresponding change in the sample resistance  $R_s$  was:

$$\frac{\Delta R_s}{R_s} = \frac{\Delta I_s}{I_s} \cdot \frac{(0.1 + R_s)}{R_s} = 3.1\%$$

Clearly, fiber breakage was a minor part of the failure process.

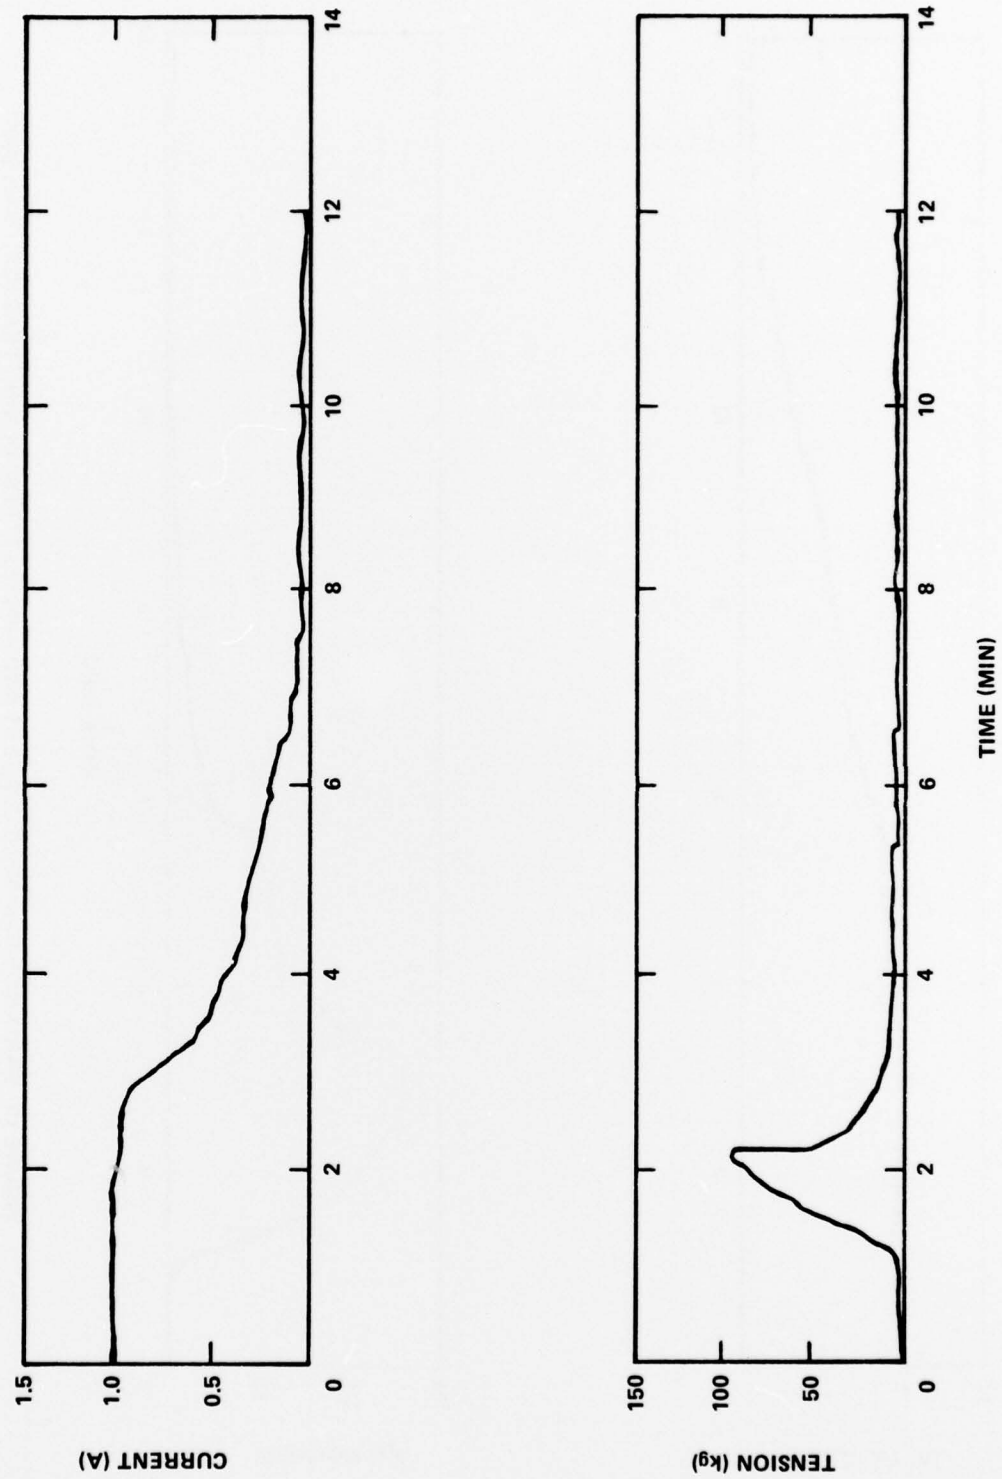
FIGURE 9 VARIATION IN SAMPLE CURRENT AND APPLIED STRESS DURING FRACTURE (NRL 2)

A second sample, NRL(2) which was unlabeled, was investigated in the same way. Its dimensions were identical to the labeled samples except that the notch was only 5/16" long. The sample had a cross-ply angle of  $\pm 11^\circ$  and failed in a manner similar to that shown in Fig. 2 but at a tension of 96 Kg (as opposed to 36 Kg). The stress/electrical test shown in Fig. 9 is similar to that just described in Fig. 8 although the fracture type is different. However, it is interesting that at the moment of stress relaxation there is no change of current. No fibers broke at that point.

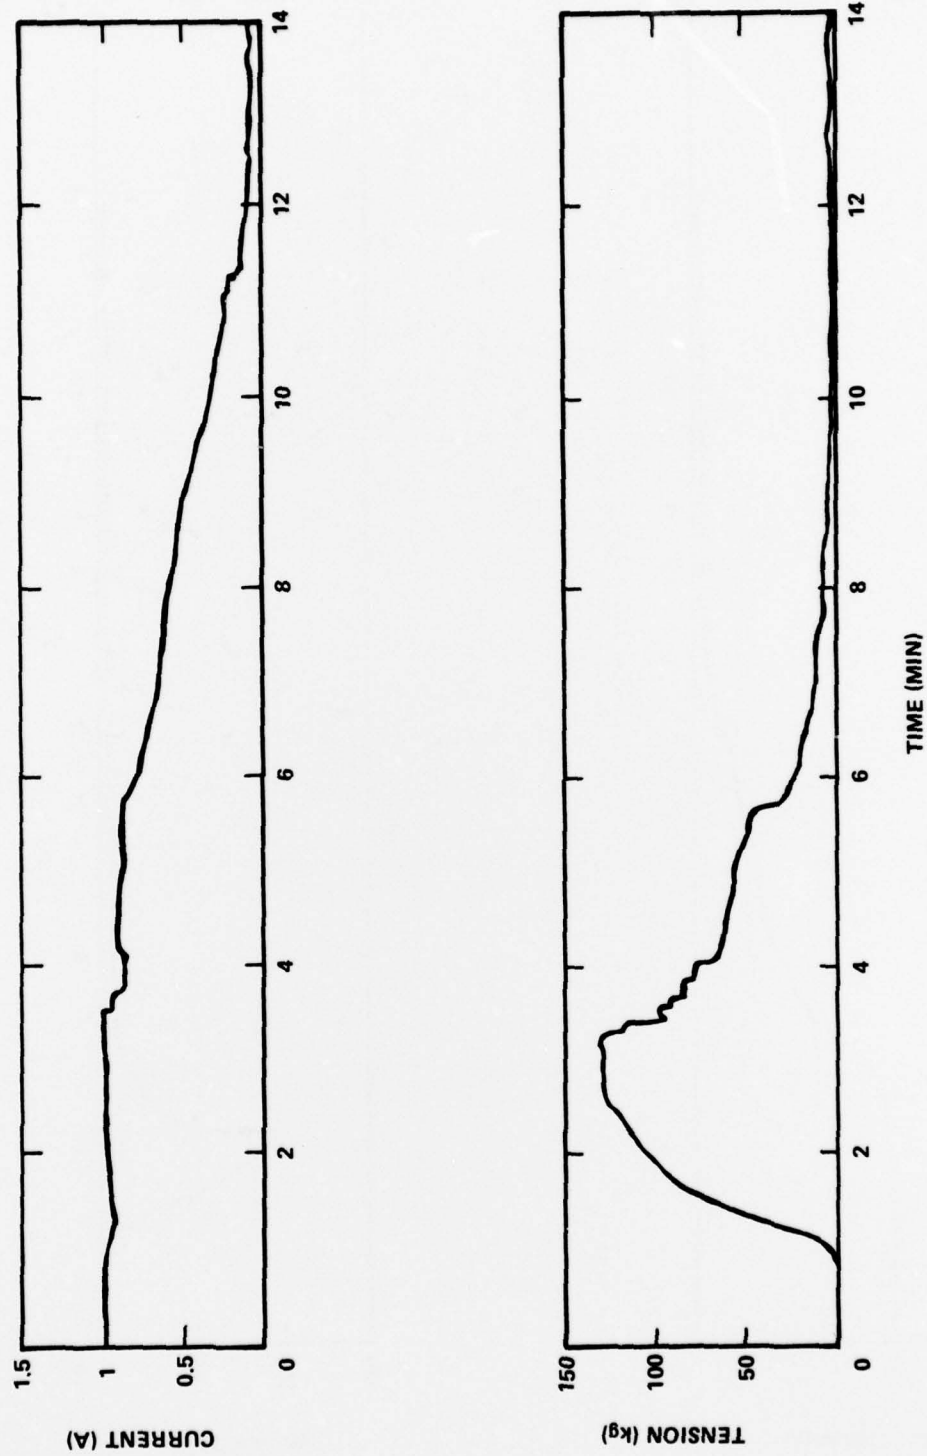
FIGURE 10 VARIATION IN SAMPLE CURRENT AND APPLIED STRESS DURING FRACTURE (NRL 580)

Two samples NRL(578) and NRL(580) which were supposedly identical to NRL(577) were studied. They both showed the dual crack fracture pattern but stress/electrical patterns differed. Their initial electrical resistances were nearly identical: 0.15 and 0.14 ohms, respectively. Their critical fracture stresses differed: 188 and 130 Kg, respectively. Sample NRL(578) exhibited a stress/electrical trace similar to that shown in Fig. 8 while that obtained for sample NRL(580) shown in Fig. 10 is quite different. The stress and the current fall in steps that must indicate a progressive breaking of lamina.

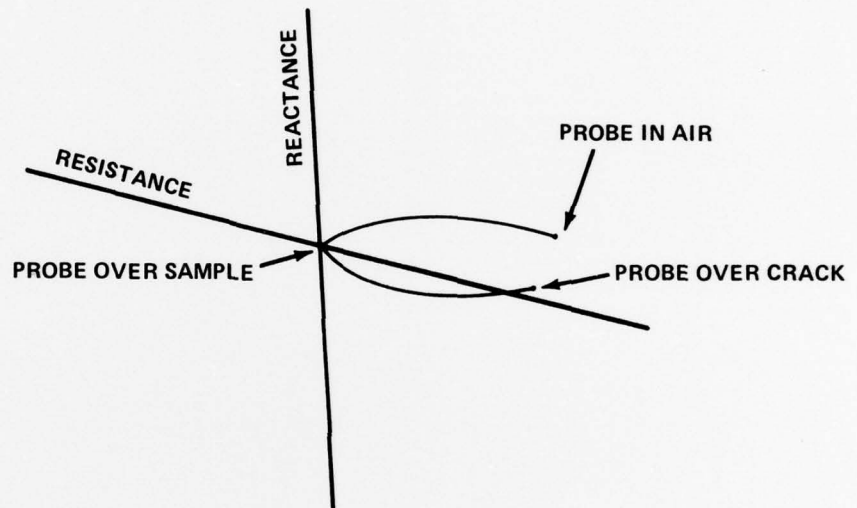
FIGURE 11 EDDY CURRENT TEST SIGNAL TRAJECTORY

The second test was a check with a commercial eddy current system at our Dahlgren laboratory by Mr. Clifford W. Anderson. The trace shown in Fig. 11 was done at 1.07 MHz but a similar one was taken at 0.501 MHz. The near vertical axis is the imaginary part of the probe impedance; the near horizontal axis is the real part. These axes are not mutually perpendicular.

The trajectory is produced by crossing a 1/32" crack while traversing the sample. A smaller probe could detect a smaller crack. However, Mr. Anderson said that the signal was strong in comparison to those found for metals.
